**THOMAS REAL ESTATE
Inspections, Inc.
Inspection Report**

MOBILE/MODULAR HOME INSPECTION REPORT

Inspection Address: **12345 W. Main St. Anytown, Ca.**

PREPARED BY: Michael A. Thomas
Date of Inspection: 09/12/06

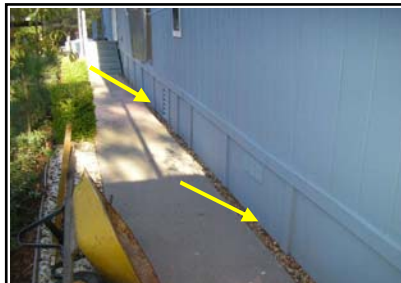
Negative grade noted along right side of unit - grading is below sidewalk & sloped towards crawl area.

Negative grade noted along right side of unit.

Recommend improvement of drainage to direct water away from foundation

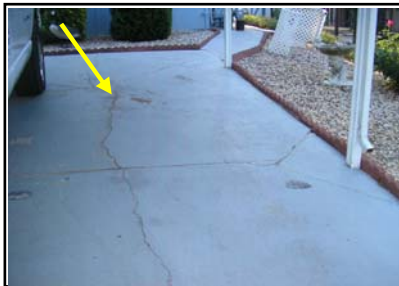
Cracking & uneven surfaces noted to driveway material - watch for uplifting edges.

Cracking & uplifting noted to driveway material.

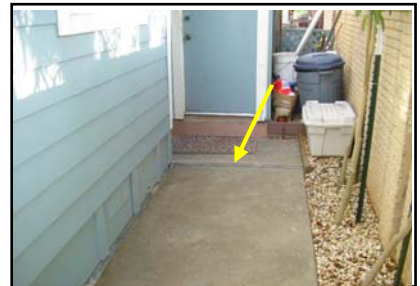
Cracking noted to walkway material. Watch for uplifted edge on rear walk.

Uplifted edge noted along rear walk.

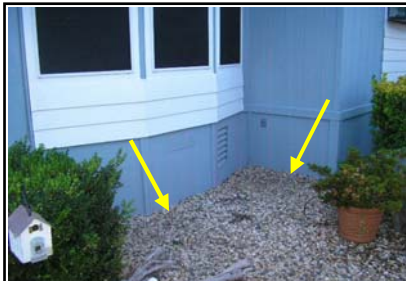
Earth to wood contact to wood skirting.

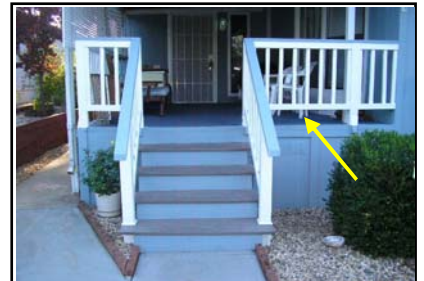
Openings under railings exceed 4 " recommended maximum.

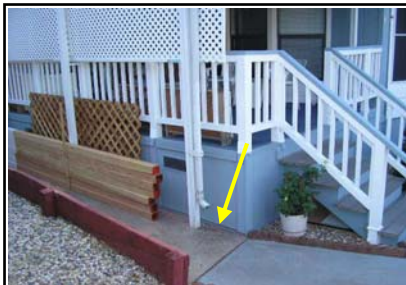
Front deck - earth to wood contact noted.

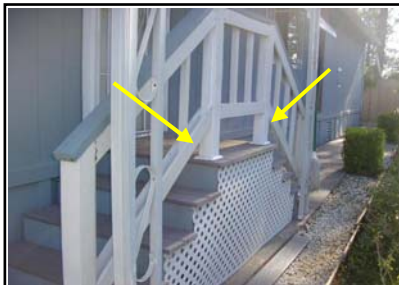
Deterioration noted to side entry railing material.

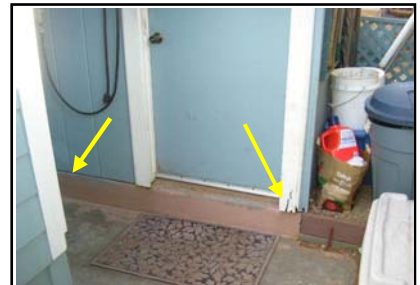
Deterioration noted to shed exterior siding & trim.

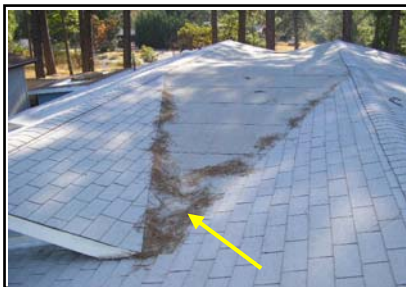
Debris noted on rolled comp roofing surface.

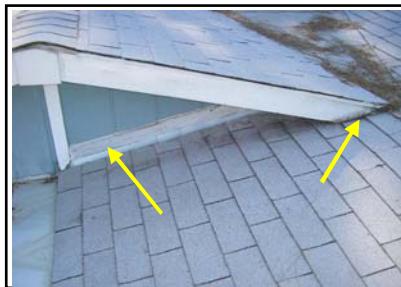
Deterioration noted to front siding trim & fascia material.

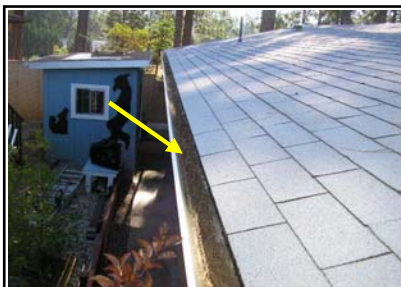
Debris noted in left side & rear gutter interiors.

Debris noted in gutters.

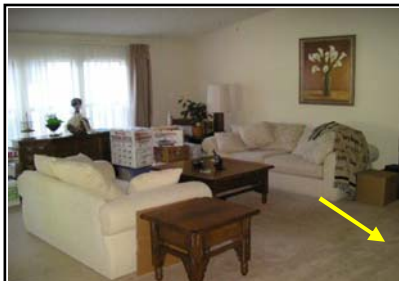
Loose & squeaking sub floor noted at right center of living room.

Living room - loose & squeaking sub floor noted.

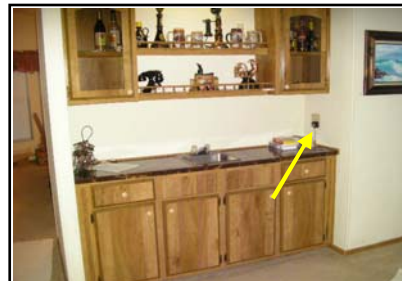
Wall outlet at wet bar is not GFCI protected - recommended.

Recommend upgrading sink outlet to GFCI.

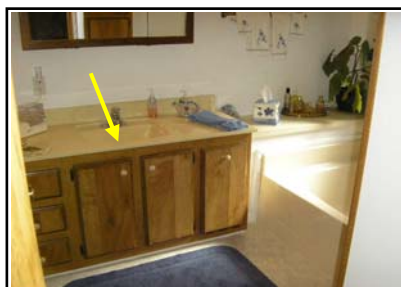
Master bathroom - sink overflow drain not draining.

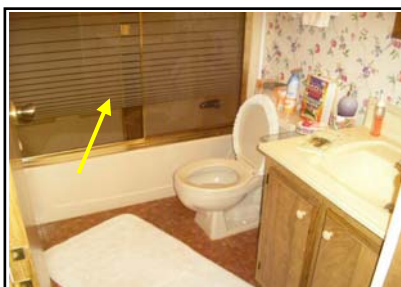
Bathroom # 2 - safety glass recommended for shower doors.

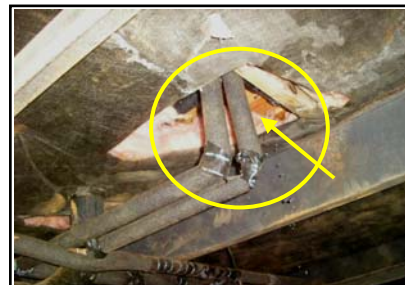
Gas supply is marked as LP gas on inlet regulator at main gas shut-off meter. Leaking noted under bathroom # 2- unable to determine source.

Leaking noted under bathroom # 2.

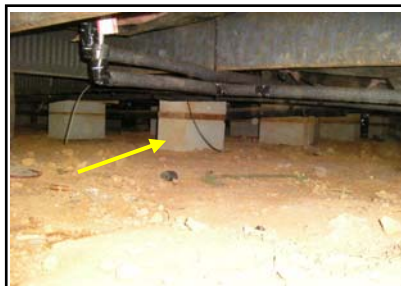
House foundation support is concrete blocks on wood bases - as with all block & steel pier foundation systems - periodic re-leveling may be required as house & soil settle which will cause un-level flooring & doors to open/ close by themselves.

House supports are concrete block on wood bases.

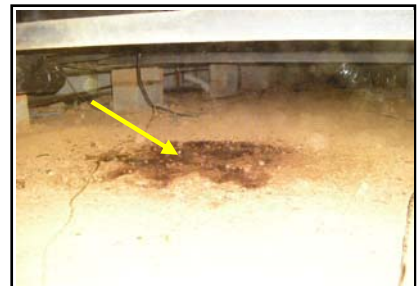
Leaking noted under bathroom # 2.
