**THOMAS REAL ESTATE
Inspections, Inc.
Inspection Report**

HOME INSPECTION REPORT

Inspection Address: **1234 Main St. Anytown, Ca.**

PREPARED BY: Michael A. Thomas
Date of Inspection: 11/6/2009

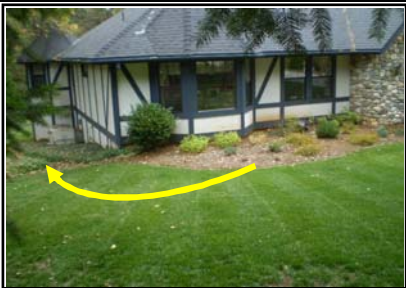
Positive grading directs water around house.

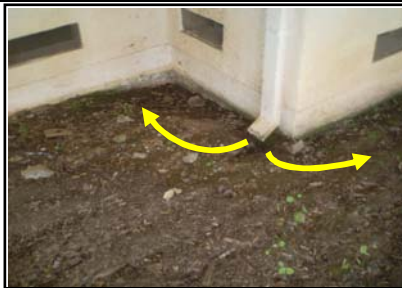
Positive grading noted around house directs water away from foundation. Downspouts are discharging roof run-off against foundation. Drain line extensions are recommended to help divert water away from house.

Downspout are discharging run-off against house.

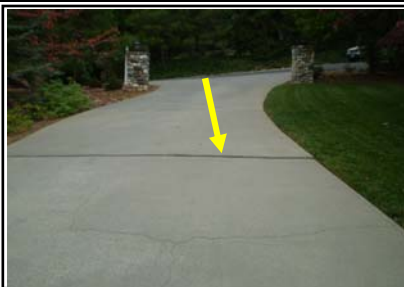
Uplifting edges noted in driveway.

Uplifting edge noted at driveway.

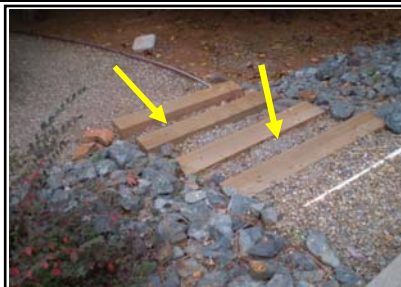
Uneven surfaces & uplifting edges noted at walkways & steps around house. Recommend consider a hand rail for right side yard steps.

Uneven step surfaces noted. Hand rail recommended.

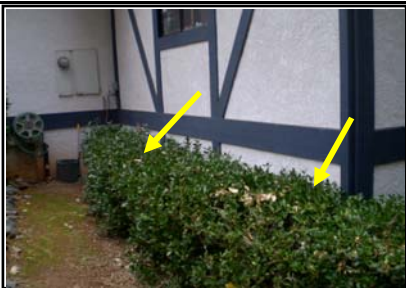
Recommend keeping vegetation trimmed away from siding.

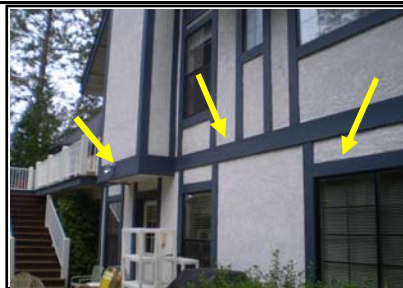
Partial use of caulking noted on exterior of house. All exterior exposed seams & edges in siding & along trim are recommended to be caulked/ sealed to help prevent water entry behind & into material. Recommend annual check of exterior caulking & re-apply as needed. Wear noted to exterior window & siding trim material. Gaps noted at trim to siding separation. Vegetation noted contacting siding may accelerate wear, trap moisture, & allow an entry point for pests. Recommend keeping vegetation trimmed off siding. Hairline cracking of stucco surfaces is common. Recommend caulking/ sealing larger cracks as needed. Failing thermo seal noted in kitchen eating nook window.

Worn & missing caulking noted along trim seams & edges.

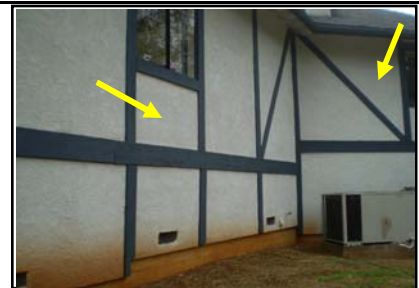
Stucco cracks were noted on the exterior, most stucco cracks are common, although some may allow for water intrusion. All stucco cracks should be sealed. The inspector is unable to detect concealed conditions behind exterior finishes.

Recommend sealing cracks in stucco surfaces.

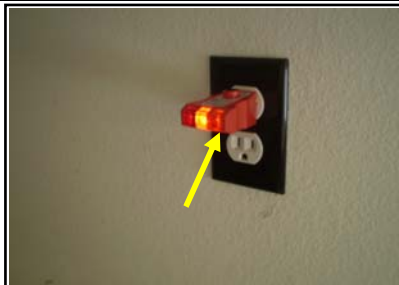
Open ground wiring noted at garage storage room outlets.

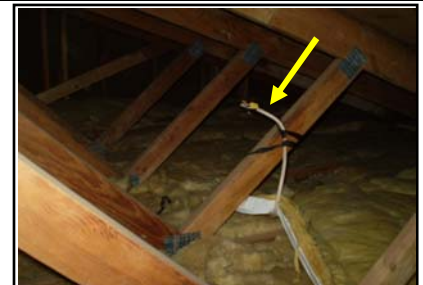
Exposed wiring noted in right rear attic.

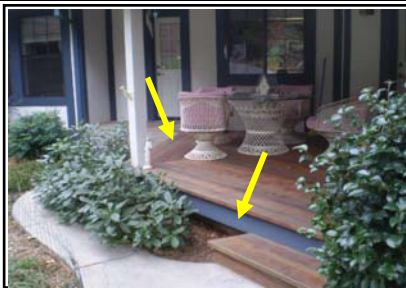
High edges noted off front decking.

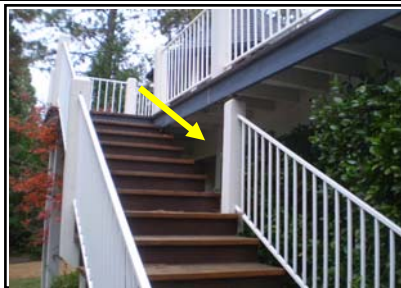
Missing railing noted on rear deck steps - hazard.

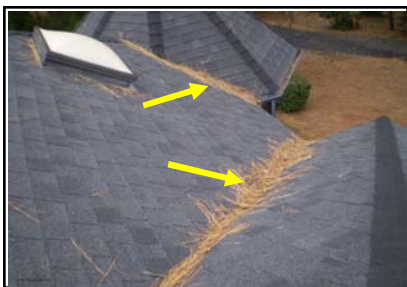
Recommend keeping debris cleared from roof valleys.

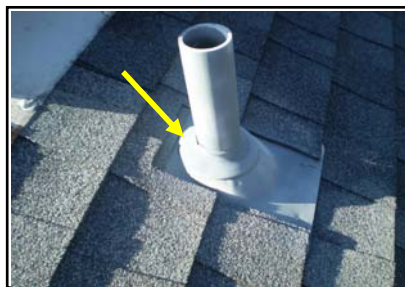
Cracked weather collars may allow water entry into attic.

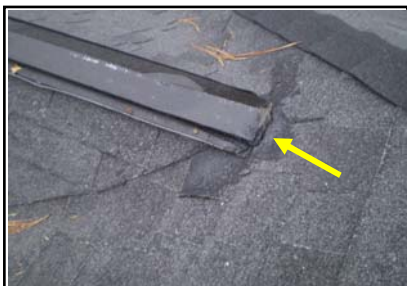
Recommend replacing worn & cracked sealant.

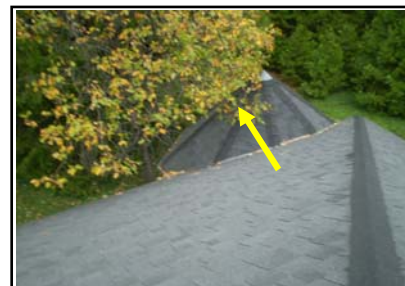
Recommend keeping vegetation trimmed off & away from roofing surfaces. Vegetation noted contacting roofing may accelerate wear, lift material, & allow an entry point for pests. Recommend clearing debris from roof valleys. Debris build-up may collect & back up water under shingles & flashing. Roof shingle surface minerals worn & loose. Recommend annual roof check & replace worn & cracked sealants as needed. Recommend replacing worn & cracked plumbing vent pipe weather collars. Gaps around worn collars may allow water entry into attic. Staining noted at plumbing vent pipe entries into attic.

Recommend keeping vegetation trimmed off & away from roofing.

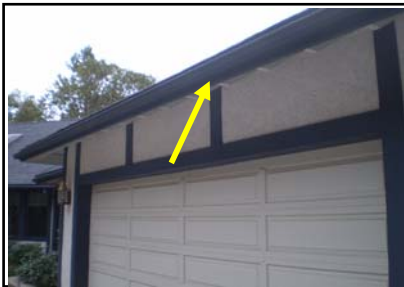
Leaking noted at multiple gutter joints. Downspouts are discharging roof run-off against foundation. Drain line extensions are recommended to help divert water away from house.

Leaking noted at multiple gutter joints.

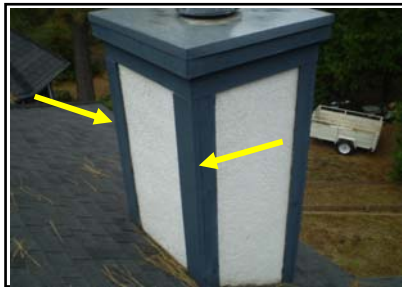
Worn caulk noted on chase exterior. Gaps along trim seams may allow water entry into chase material. Recommend keeping chase seams & edges caulked/ sealed.

Recommend keeping chimney chase exterior caulked/ sealed.

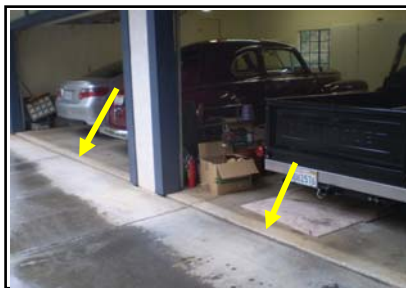
High edges noted across garage entry.

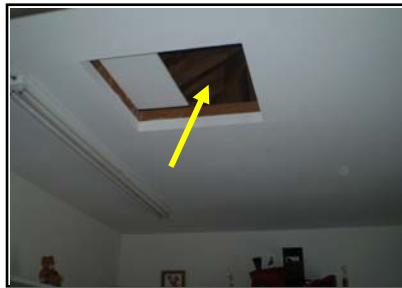
Attic access opening reduces garage to house fire protection.

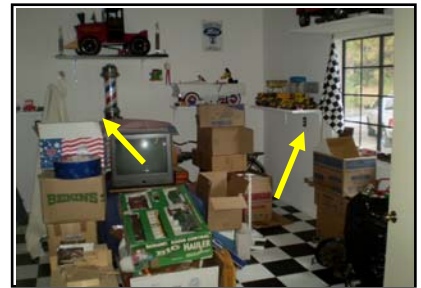
Open ground wiring noted at storage room wall outlets.

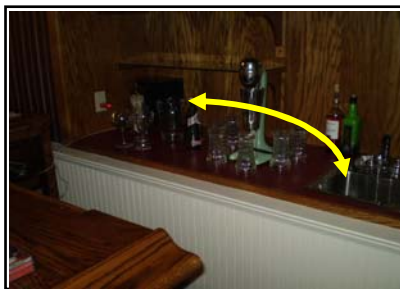
Wet bar counter outlet is not GFCI protected - recommended.

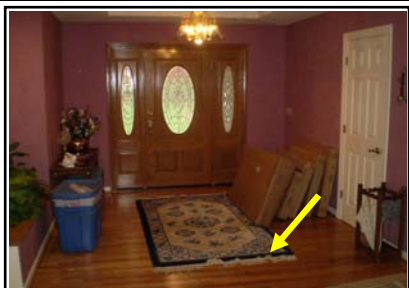
Front entry shading noted to flooring at area rug.

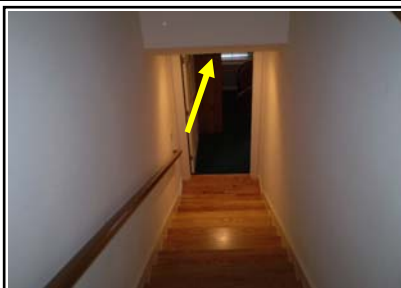
Low head clearance noted at bottom of stairs.

Low head clearance noted down stairs.

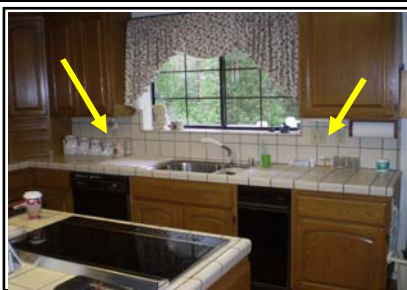
Kitchen counter outlets are not GFCI protected - recommended.

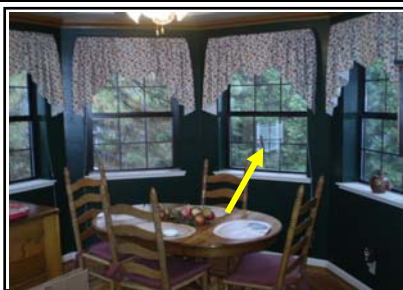
Failing thermo seal noted in eating nook window.

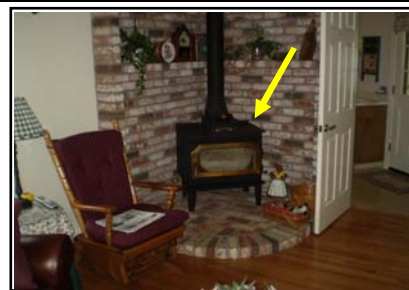
Unable to verify wood stove clearance recommendations.

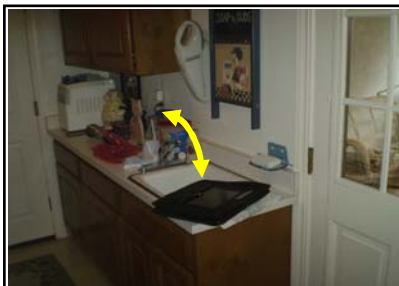
Sink counter outlet is not GFCI protected - recommended.

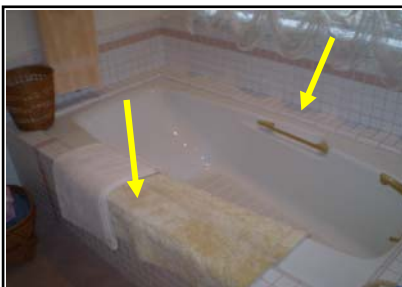
Master bathroom - recommend regular tile sealant application.

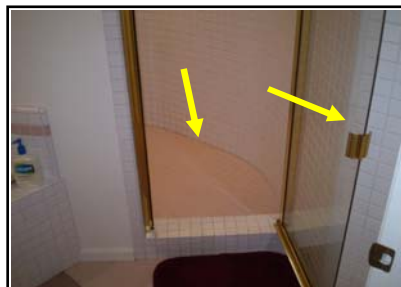
Shower door opens against wall. Keep seams & edges sealed.

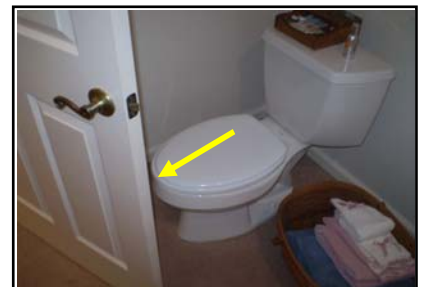
Bathroom door opens against toilet.

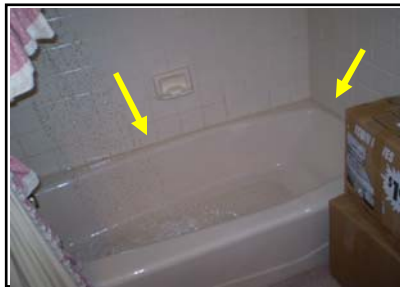
Recommend keeping seams & edges sealed.

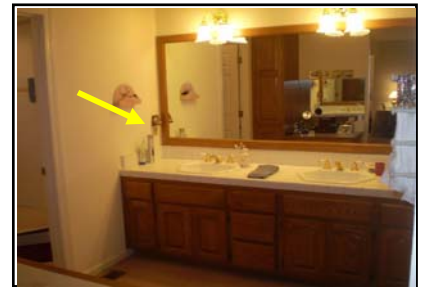
Bathroom # 2 GFCI reset is located in master bathroom.

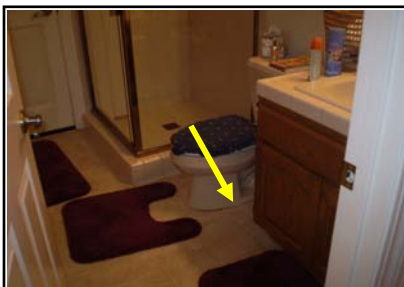
Bathroom # 3 - toilet is not secured to floor.

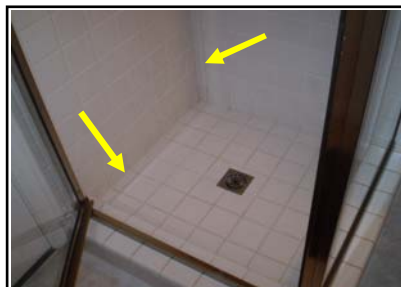
Recommend keeping shower seams & edges sealed.

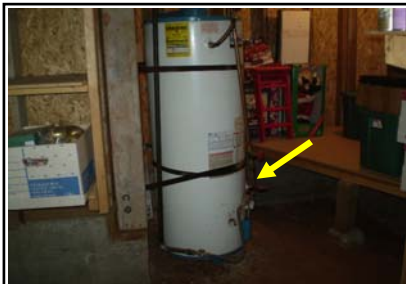
WH # 1 - older unit. SRV is not drained to building exterior.

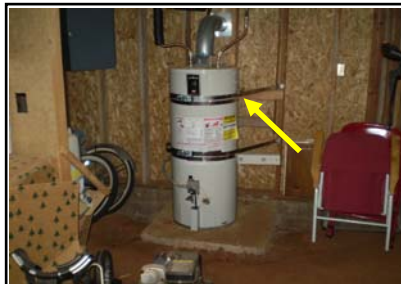
WH # 2 - newer unit. SRV is not drained to building exterior.

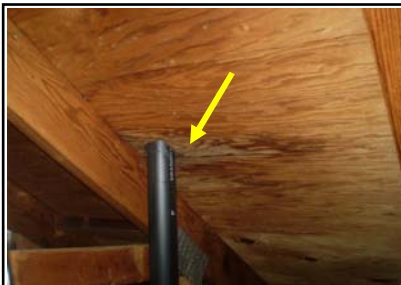
Staining noted at vent pipe entry through roofing.
